Sample Radiological Report

Digital *motion* x-ray®

Digital Motion X-ray - Cervical Spine

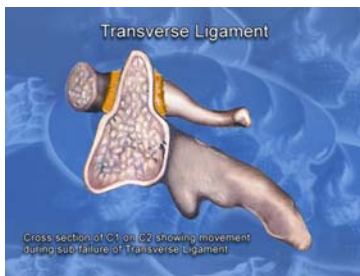
Increased ADI space

This view examines the integrity of the transverse ligament which is responsible for preventing the anterior movement of C1 on C2. An increase of the Atlanto-Dens interspace (ADI) indicates damage to the transverse ligament.

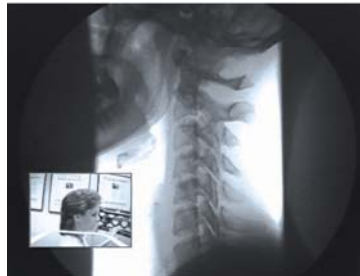
1. Neutral lateral projection

1. In the neutral lateral projection: there is a reversal of the cervical lordosis with the apex of the reversal at the C5-C6 level. There is narrowing and degenerative changes at the C6-7 intervertebral disc space.

The integrity of the cervical lordosis and overall condition of the cervical spine is evaluated. The loss of the cervical lordosis may be a result of damage to the posterior longitudinal, capsular or interspinous ligaments.

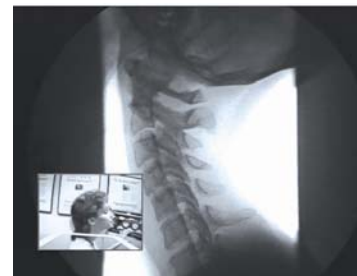
2. Lateral nodding projection

2. In the lateral nodding projection: Motion is within normal limits. There is a tilting of the C1 vertebrae laterally.

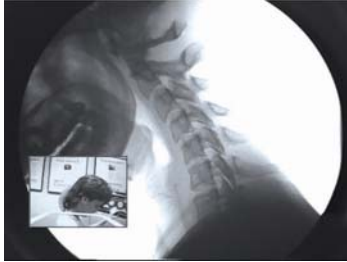
3. Full flexion projection

3. Motion in the neutral lateral projection to full flexion: Shows an anterolisthesis of C5 on C6.

This view examines the integrity of the posterior longitudinal ligament demonstrated by a forward (anterior) movement of one vertebrae over the vertebrae below or by the posterior widening of the intervertebral disc space (increased disc angle).

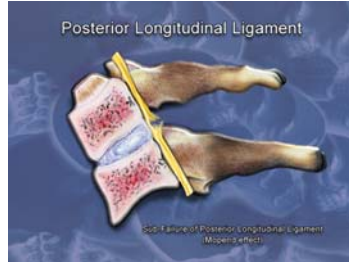
Widening of posterior disc space

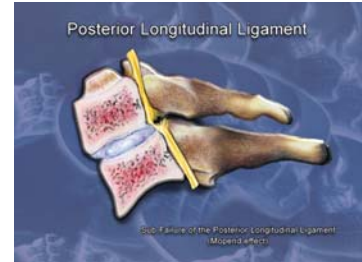
Anterolisthesis

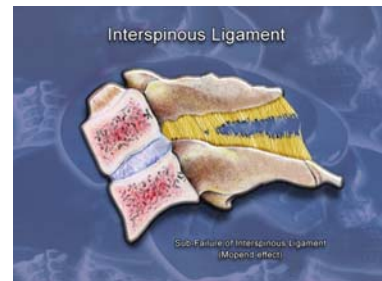
The integrity of the interspinous ligament is evaluated in the lateral flexion view. Damage to this ligament results in increased separation of the spinous processes in flexion.

Damaged Interspinous Ligament

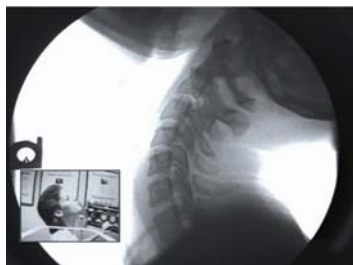
4. Full Extension

4. Motion in the neutral lateral projection to full extension: Shows a retrolisthesis of C2 on C3, C3 on C4, C4 on C5.

This view examines the integrity of the anterior longitudinal ligament demonstrated by a backward (posterior) movement of one vertebrae over the vertebrae below or by the anterior widening of the intervertebral disc space (increased disc angle).

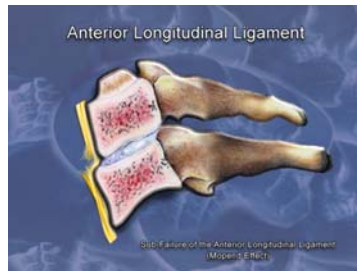
Retrolisthesis

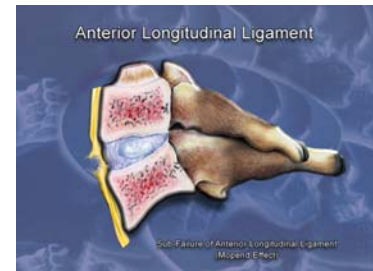
Widening of the anterior disc

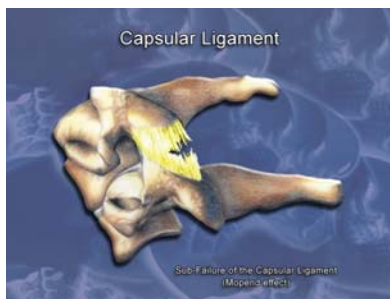
This view examines the integrity of the capsular ligaments by observing gapping of the facet joints, located on the posterior cervical spine (C2-C7), there are five capsular ligaments on the right and the left.

Capsular ligament damage

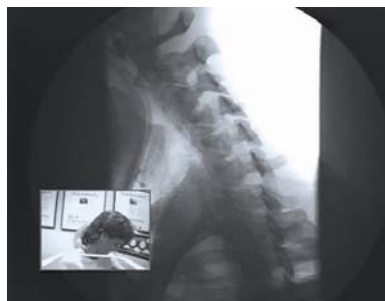
5. Right IVF flexion

5. Motion in the right and left oblique flexion projection: Shows gapping of the facet joints bilaterally at C6-C7, C7-T1.

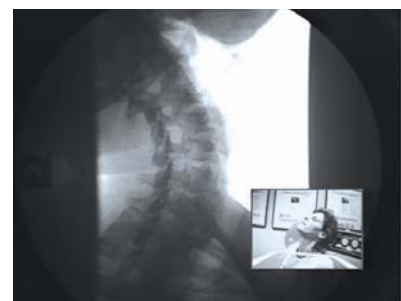
6. Left IVF oblique extension

6. Motion in the right and left oblique extension projection: Shows intervertebral foraminal encroachment on the right at C4-C5 and on the left at C3-C4.

This view examines the integrity of the capsular ligament by encroachment into the intervertebral foramen, located on the posterior cervical spine (C2-C7), there are five capsular ligaments on the right and the left.

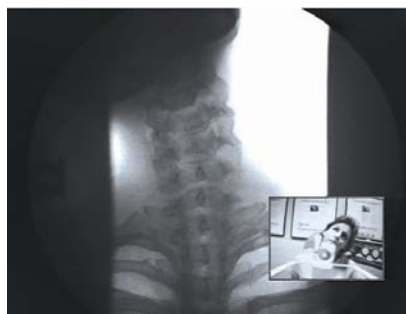
Left lateral bending

7. Motion in the A-P lateral bending projection: Is restricted bilaterally.

This view allows us to evaluate coupled motion of the spinous processes which examines facet joint integrity.

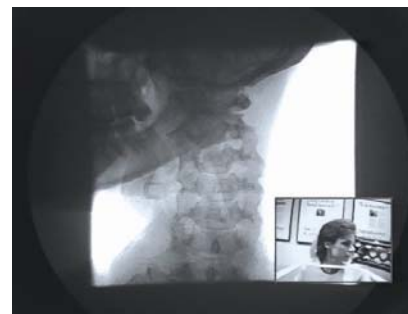
Left rotation

8. Motion in the A-P rotation projection: Is within normal limits.

This view examines the rotational range of motion between Occiput-C1-C2. Increased motion indicates damage to the alar and accessory ligaments.

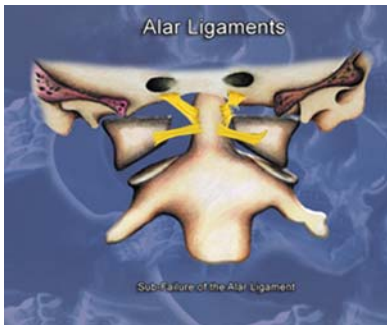
This view examines the integrity of the alar and accessory ligaments either by the lateral overhang of C1 on C2 or by the changes in the para-odontoid spaces.

C1 lateral mass overhang

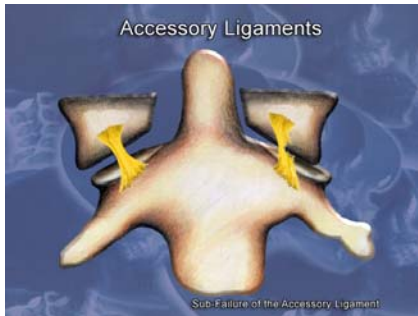
Change in Para-odontoid space

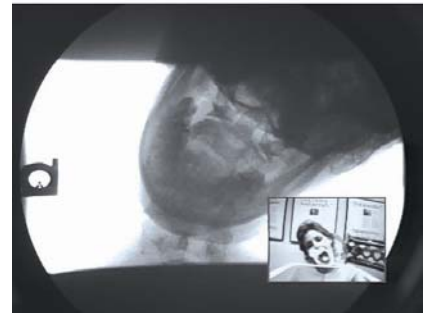
9. Open mouth right lateral bending

9. Motion in the A-P open mouth lateral bending projection: Shows an abnormal lateral translation of C1 on C2 with an overhang of the lateral mass of C1 bilaterally. Change is noted at the para-odontoid space bilaterally during lateral bending.
